Manhole Inspection Summary

Manhole # S25CC_025MH

Insp Date: **7/19/07 10:38 AM**

Location Address: **1017 SMITHSON ST**

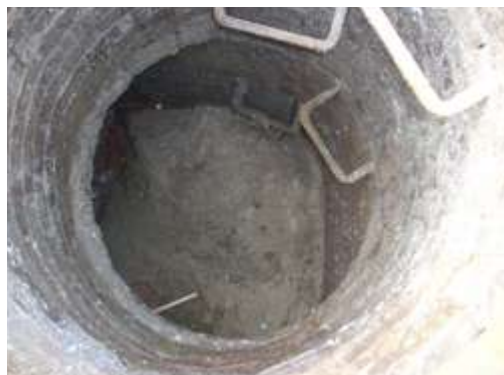
Top View

abandoned pipe at i4

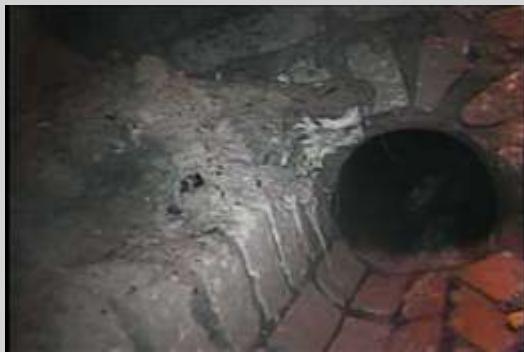
12 O'Clock Outflow

8 in. Circular Gravity Sewer
Pipe Out @ 12 O'Clock

Pipe Height: **8.4** (in.) Rod and Bar (Angled)
Pipe Material: **Clay** ☐ Pipe Lined
Invert Depth: **8.46** (ft.) Flow Characteristics: **Slow**
Deposits: ☒ None ☐ Mud ☐ Sludge ☐ Debris ☐ Grease
Silt Depth: (in.) Deposits Extent:
Infiltration: **None** Pipe Seal Cond: **Sound**

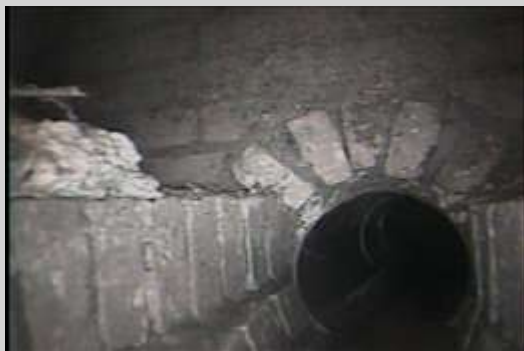
9 O'Clock Inflow

8 in. Circular Gravity Sewer
Pipe In @ 9 O'Clock

Pipe Height: **8.4** (in.) Rod and Bar (Angled)
Pipe Material: **Clay** ☐ Pipe Lined
Invert Depth: **8.40** (ft.) Flow Characteristics: **Slow**
Deposits: ☒ None ☐ Mud ☐ Sludge ☐ Debris ☐ Grease
Silt Depth: (in.) Deposits Extent:
Infiltration: **None** Pipe Seal Cond: **Sound**
